BUILDING REPORT

WATTS CEMETERY CHAPEL & CLOISTER COMPTON, GUILDFORD, SURREY, GU3 1DQ

Client: The Watts Gallery
PCS Ref: PGA/1829/12
Date: May 2012
Issue: 1
Surveyor: Philip Acton BSc (Hons) MRCS

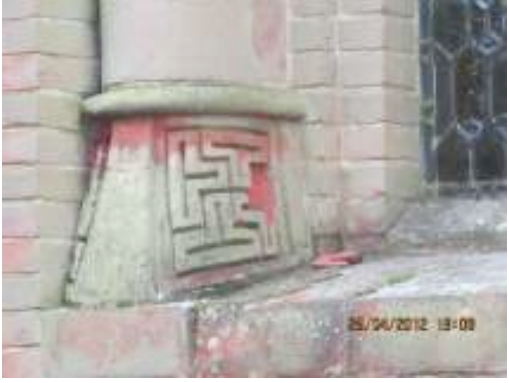
- 4.1.4 The condition of the terracotta brickwork and decorative pieces has deteriorated and cracking and spawling (pieces flaking and falling off) can be seen in several areas especially where rainwater becomes concentrated (Images 7, 8, 9, 10 and 11). Inevitably some deterioration will occur, particularly where these decorative items are fragile and exposed to the weather. However, given the building's Grade I listing it will be necessary to ensure that restoration works are programmed and carried out stringently and sympathetically to an exacting specification to match the existing. We would recommend that all terracotta items including deteriorated brickwork and decorative features are repaired and renewed as required as part of an overall external refurbishment project.

A close-up photograph of a wall section showing spawled terracotta detailing. The wall is composed of light-colored, rectangular blocks. A decorative element, possibly a window surround or a niche, is visible, featuring a complex geometric pattern. A timestamp '25/04/2012 13:00' is visible in the bottom right corner of the image.	Spawled terracotta detailing

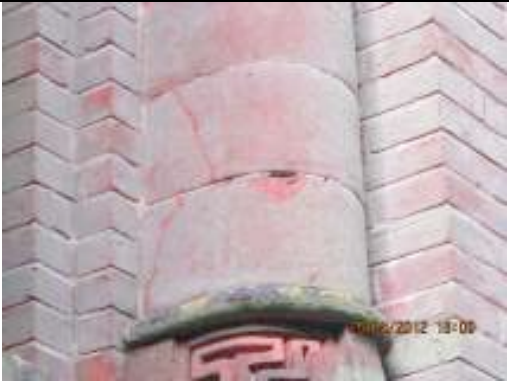
A close-up photograph of a spawled terracotta column. The column is made of reddish-brown terracotta blocks and is positioned next to a window opening. The surrounding masonry also features spawled terracotta detailing. A timestamp '25/04/2012 13:00' is visible in the bottom right corner of the image.	Spawled terracotta column to side of window opening

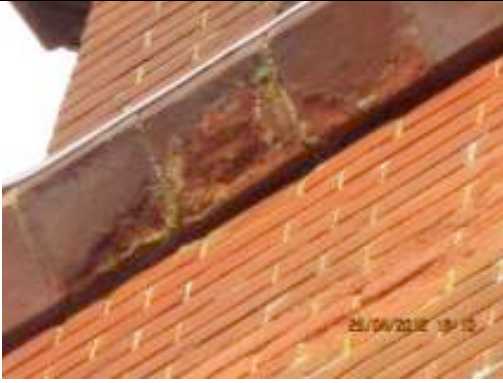
Spawled terracotta corbel course to bell tower
10

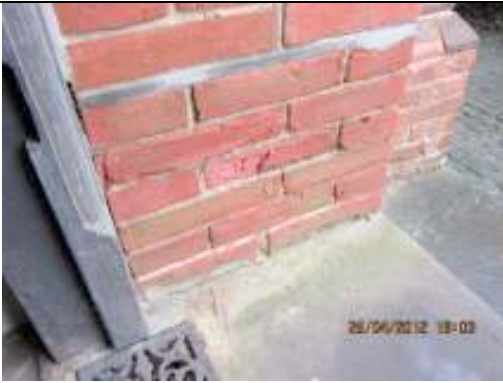
Spawled brick plinth adjacent to the entrance door
11

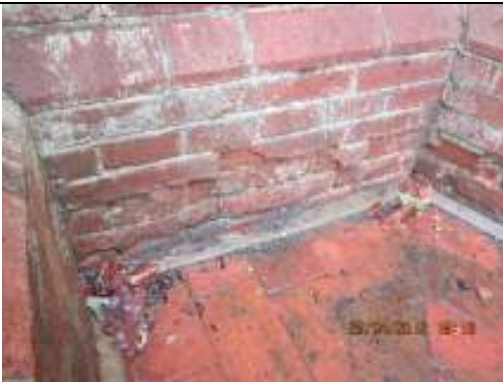
Spawled brick plinth
12

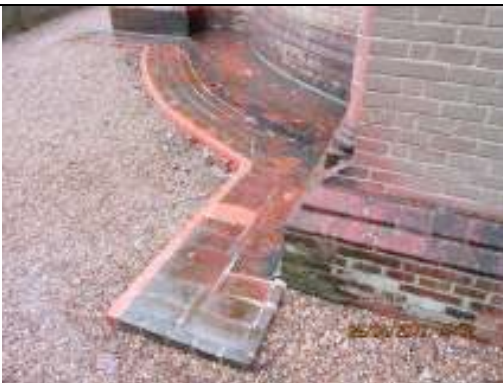
Rainwater gully within brick paving Note: previous replacement bricks (non-matching)

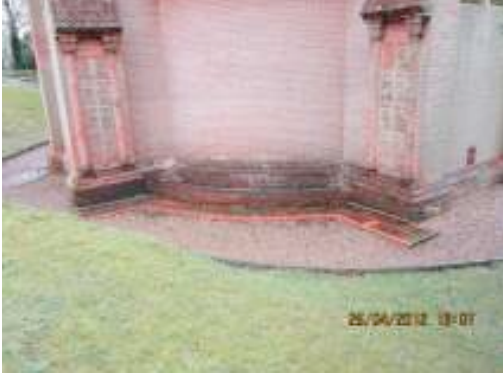
- 4.1.5 A main contributory factor to the deterioration of the building fabric externally is the effect of dampness on the building. There are no rainwater gutters on the building and the system of disposal is simply to allow the rainwater to drip off the roof edges onto the brick paviors below. These are set to slight falls to direct the water into small gullies (Image 12). The water splashes onto the paviors and onto the walls of the building and a 'water line' can be seen which attracts green coloured algae growth (Image 13). The problem is further exacerbated by the shading of the trees to the east side, which restricts the sun from drying the building (Image 14). There is a lot of green growth to the elevations indicating that the walls are damp and in many areas to the plinth the dampness has caused deterioration of the brick joints (Image 15). We would recommend that the green algae growth should be removed and all open joints and localised repointing carried out to the brickwork. There are a number of methods to clean buildings in this condition and a non-abrasive method should be employed. Given the fragile nature of the brickwork and terracotta we would recommend that a trial should be carried out using washing techniques with water and brushes which should be undertaken in the summer months to avoid problems associated with cold weather.

Rainwater splashing onto building saturating the brick plinth and creating a 'water line'
14

- 4.1.6 To provide a long-term solution to the abovementioned damp issues we would recommend two mitigation items. Firstly the trees should be cut back and thinned to allow sunlight through to the building and secondly, a new system to deal with the rainwater run-off should be installed. This could be dealt with in two ways; either new gutters and downpipes should be installed to collect the rainwater, or new gully channels should be provided within the paviors to directly catch the rainwater and avoid it splashing up onto the building. New gutters and downpipes would alter the aesthetics of the building but would be extremely effective in dealing with this issue. New gullies would need careful detailing and these would need to be curved to suit the profile of the external walls but these would be less visually obtrusive. Both options would require listed building consent and careful design but nevertheless they would prevent further deterioration by providing a much more effective means of directing rainwater away from the building.

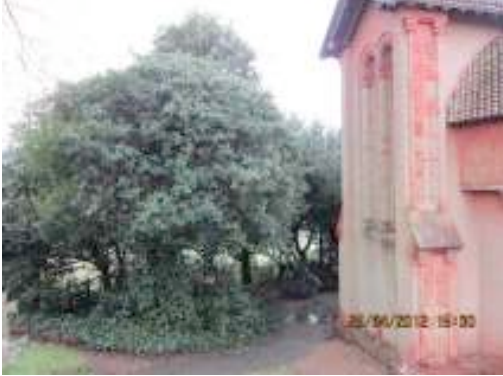
<p>Trees shield the building preventing drying out by the sun</p> <p>Note: Green algae growth over the façade</p>
15

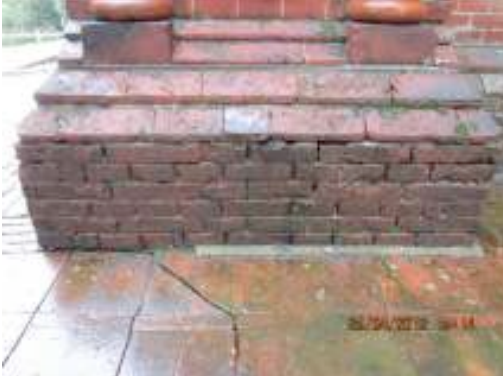
Dampness causing deterioration of the brickwork with open joints where mortar has fallen out
16

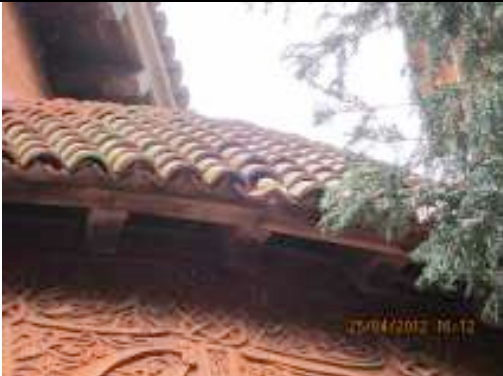
- 4.2.2 We understand that the roof was retiled in 1994 and from the limited view afforded by binoculars from ground level overall the roof looks to be in reasonable order. However, we did note one missing tile to the edge of the roof above the 'Frieze of Truth' which requires replacement (Image 16).

Missing tile to roof edge (centre of picture)

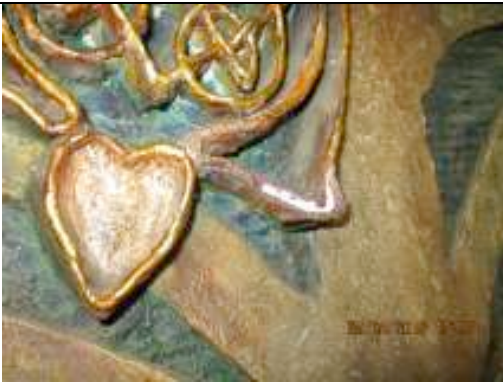
- 4.3.2 Generally the plasterwork appears sound, however, upon close examination cracking and defective detailing can be observed which should be monitored and repairs carried out as deemed necessary (Image 19 and 20). Clearly this work should be undertaken by a specialist, conversant in the skills and materials which will match the existing. As part of this work, the plasterwork should be closely examined to check its stability and ensure there still remains a secure attachment to the structure. Depending on the findings of this investigation it may be necessary to provide additional fixings.

Decorative plasterwork requires some specialist repairs
20

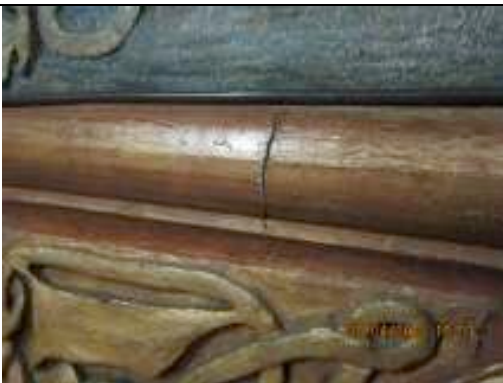
Crack to plaster decorative band

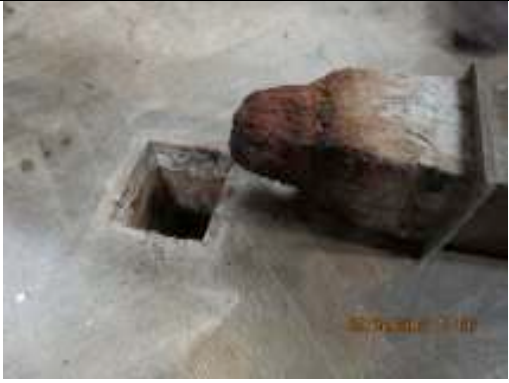
- 4.3.4 To the centre of the floor there is an oak lectern which is set within a socket in the floor. The base of the support post is severely rotten from the effects of dampness within the floor (Image 21 and 22). It is likely that the parquet flooring has been laid on a bitumen layer in the traditional manner and clearly this is penetrated in this location. We would recommend that localised remedial works are undertaken to provide a waterproof socket and the lectern is repaired to replace the rotten base.

Rotten oak post to lectern
22

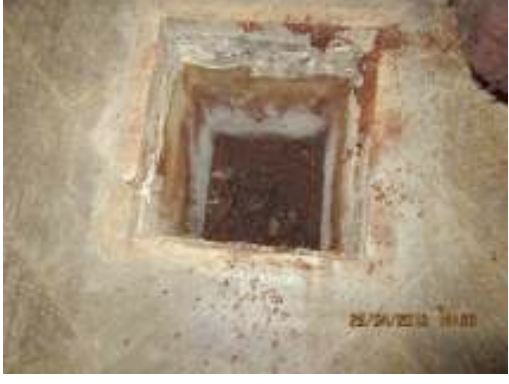
Floor socket the source of dampness
23

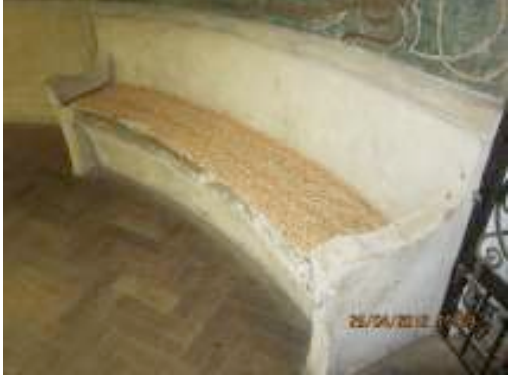
- 4.3.5 The interior of the chapel has numerous fittings such as the stone benches which curve to the shape of the walls (Image 23) together with decorative ironwork and oak doors (Image 24). These items are all original and are showing signs of wear and tear as would be expected for a building of this age. We would recommend that as part of an overall refurbishment programme these are restored and repaired as necessary.

<p>Curved stone benches</p> <p>Note: chipped and worn edges</p>
24

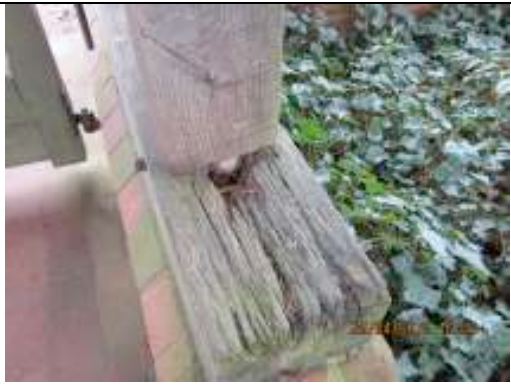
<p>Rot to joint on lych gate</p>
<p>27</p>

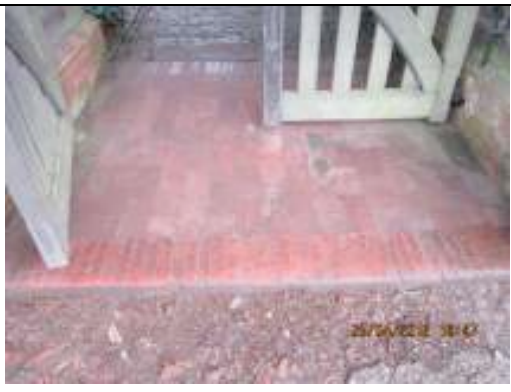
<p>Worn floor to lych gate</p>
<p>28</p>

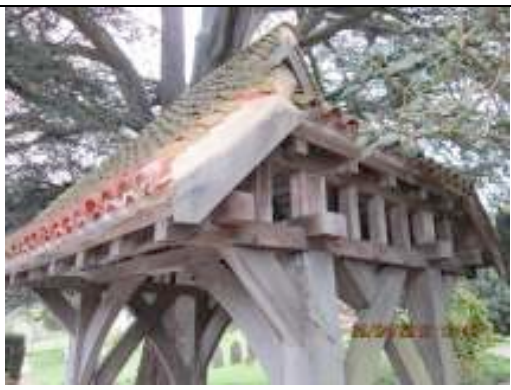
The lych gate to the front of the cemetery is an original feature constructed with the Chapel. This is showing signs of deterioration as one would expect of a structure standing for over 100 years and in particular the oak timber framing requires repair where rot has occurred to the joints between the posts and the sole plates (Image 26). The terracotta floor to the lych gate is very worn and consideration should be given to replacing this (Image 27). The tiling to the front right hand side of the roof has been repaired and repointed in recent years but this has been carried out with little consideration to matching to the existing and is so unsightly it should be replaced (Image 28).

<p>Poorly repaired roof to lych gate</p>

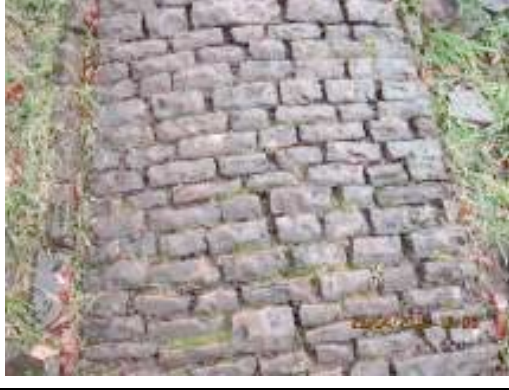
<p>Open jointed defective area of paving</p>
<p>31</p>

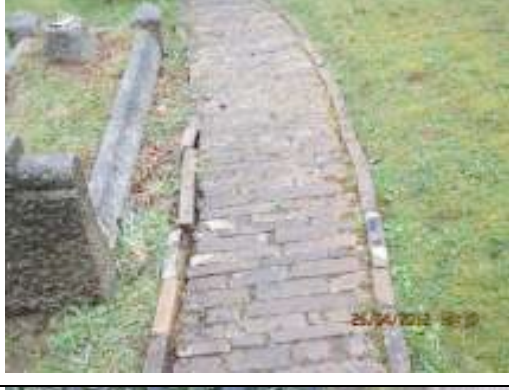
<p>Loose edging to path</p>
<p>32</p>

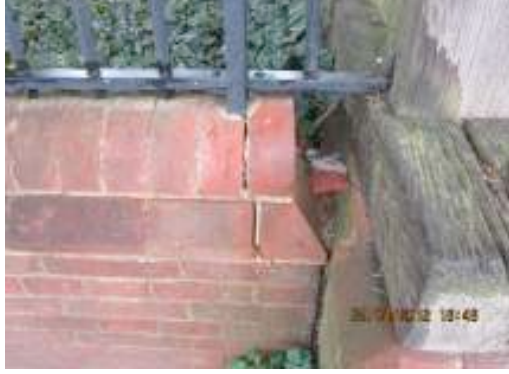
The boundary fences and walls to the cemetery are in various materials and conditions. The front wall adjacent the road has, in relative recent years, been rebuilt with new iron railings. This has dislodged brickwork adjacent the lych gate which should be re-bedded especially as it is in view at the front of the site (Image 32).

<p>Defective brickwork to front wall adjacent the lych gate</p>

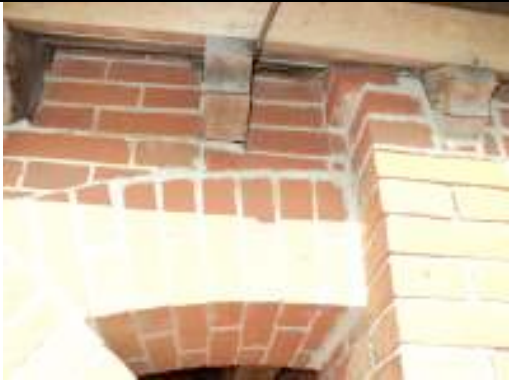
- 6.1.2 Some minimal cracking is evident to the brickwork indicating general movement which is to be expected for a building of this nature. However there is structural cracking to the front elevation around the arched brickwork to the eaves of the building which will require remedial works (Image 33 and 34). In addition, there is loose brickwork at eaves level where movement has occurred to the roof timbers over time. There are also a number of bricks which have become loose and dislodged which require repair (Image 35). We would recommend that the movement is monitored and as part of a refurbishment project, repairs are carried out which will encompass some rebuilding to localized failed areas.

<p>Cracking to brickwork at the front of the Cloister</p>
<p>34</p>

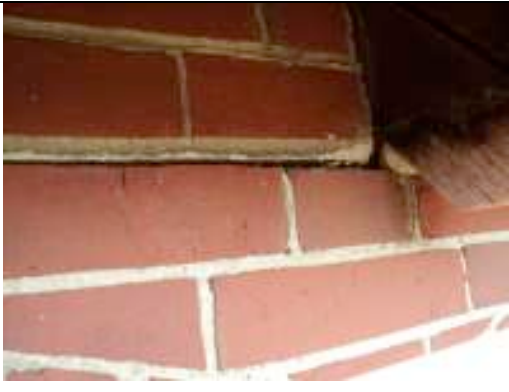
<p>Crack in close up</p>
<p>35</p>

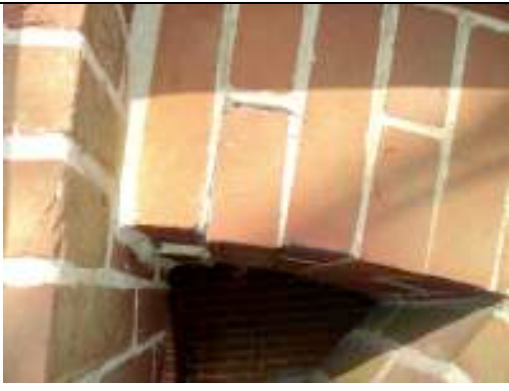
<p>Dislodged brick</p>
<p>36</p>

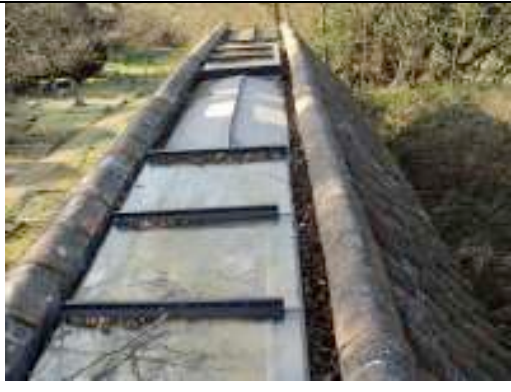
<p>Roof over the Cloister</p> <p>Note: leaves and debris</p>
<p>39</p>

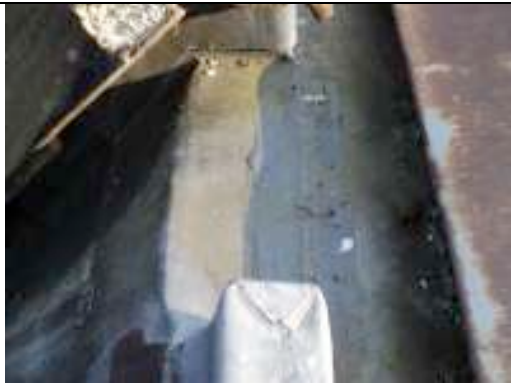
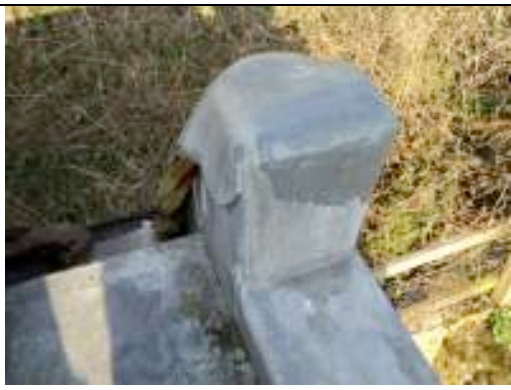
6.2.5 Despite the reroofing project undertaken in 1994 the roof is failing in a number of areas. The zinc and lead work has already had numerous repairs carried out and roofing repair compound can be seen to have been applied (Image 39 and 40). The ridge tiles are badly deteriorated with many delaminating (Image 41). These tiles have been bedded using a poor lime mortar (presumably a weak hydraulic lime

<p>Previous repairs to roof</p>
<p>40</p>

<p>Previous repairs to roof</p>

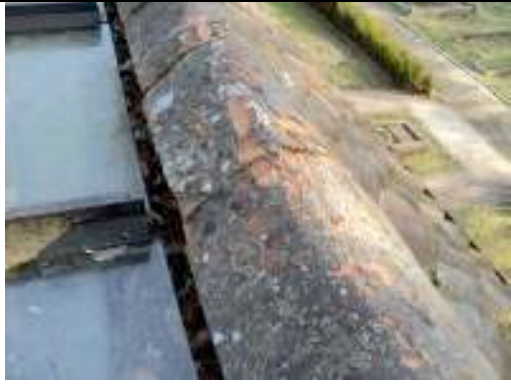
Delaminating ridge tiles
42

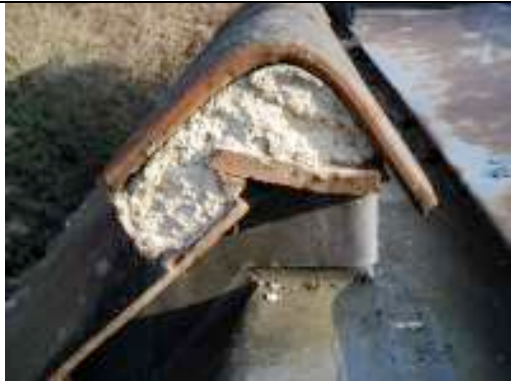
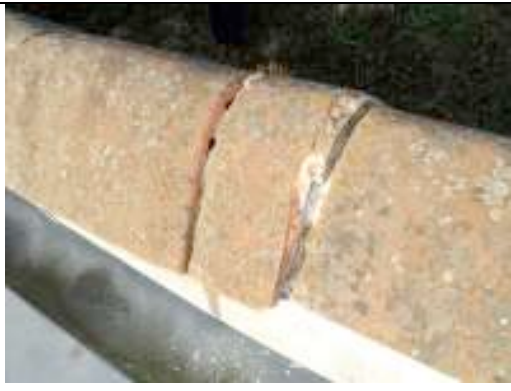
mortar) which has not proved durable and has completely failed (Image 42). The mortar is flaking away as it weathers and in the majority of cases the pointing between the tiles has eroded such that water can enter the joint and percolate down in to the roof (Image 43). Most ridge tiles can simply be lifted off as there is little holding them in place (image 44).

Defective mortar
43

Defective mortar
44

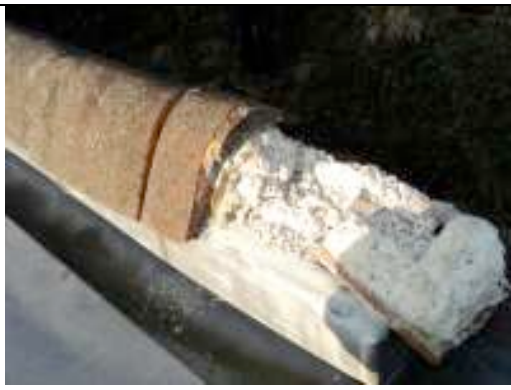
Tiles can be simply lifted off
